STERILIZABLE ACCELEROMETER
FOURTH QUARTERLY TECHNICAL REPORT

BELL REPORT NO. 60007-029

AUGUST 22, 1967

REPORTING PERIOD MAY 1967 THROUGH JULY 1967

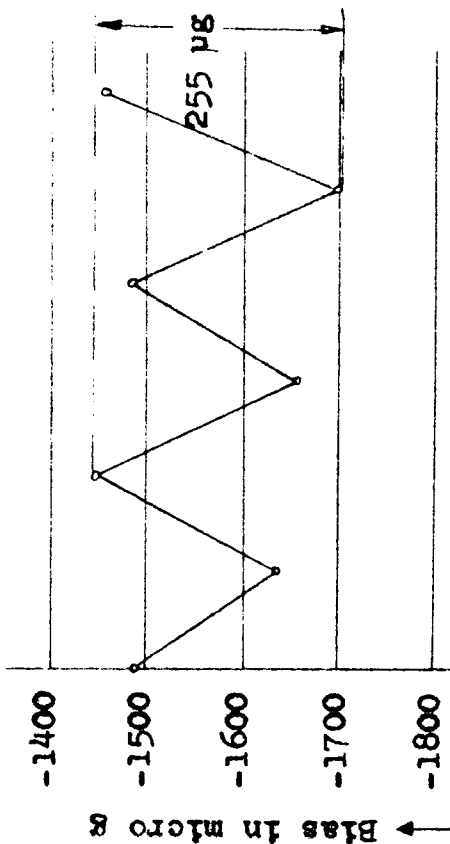
Before temperature sterilization
With electronic assembly E7
June 1967

Accelerometer M-225
Flip-Flop Return Points
Epoxy in Spring-to-Support Joints: Scotchweld EC 2258
